Ensuring Shield Integrity in Field Testing

SMART BUILDINGS TECHNOLOGY

Introduction

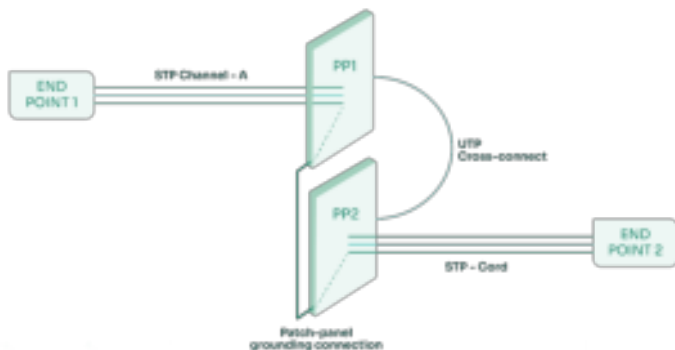
Fig 1 - DC continuity present but shielding compromised

Commonly, shield integrity is verified by simple DC continuity measurements. However, there are situations where shield integrity might be compromised despite having end-to-end DC connection of the shield conductor. Even when the channel has one or more unshielded components, there may be an alternate DC conduction path, for example, through grounding of the patch-panels (Fig. 1). When such alternate conduction path is present for shield, simple continuity measurement may give a false PASS. The good news is, even in such cases, testers like TestPro and NSA can detect shield discontinuities through AC (RF) measurements. Further, these tools pin-point the location where shield discontinuity is detected, which is extremely useful information while troubleshooting the shield issues.

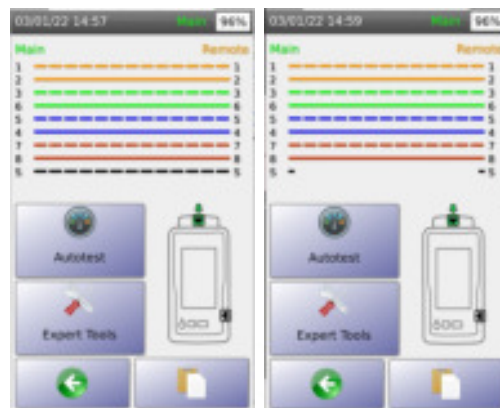
Fig 2 - Cable with good shielding and broken shield (DC shield discontinuity)

First, a regular check on DC continuity is performed using wiremap measurement. Fig. 2 shows two scenarios, one with good shield, and second with open shield. After performing DC continuity check, as an integral part of the RF measurements, the tester performs a special type of measurement called CMRL (common mode return loss) on each pair of the cabling. By analysing the variations on CMRL along the length of the cable, shield defects can be accurately identified (even in the presence of alternative DC conduction path). Let's look at how this is done.

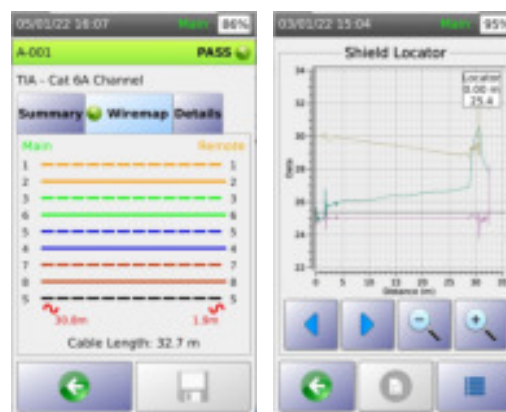
Fig 3 - Cable with AC shielding discontinuity and its time domain locator plot

As seen from Fig. 3, a cable having AC shield discontinuity is detected by the tester accurately. The tester also provides a locator (time-domain) plot of the measurement for in-depth analysis of the cable behaviour.

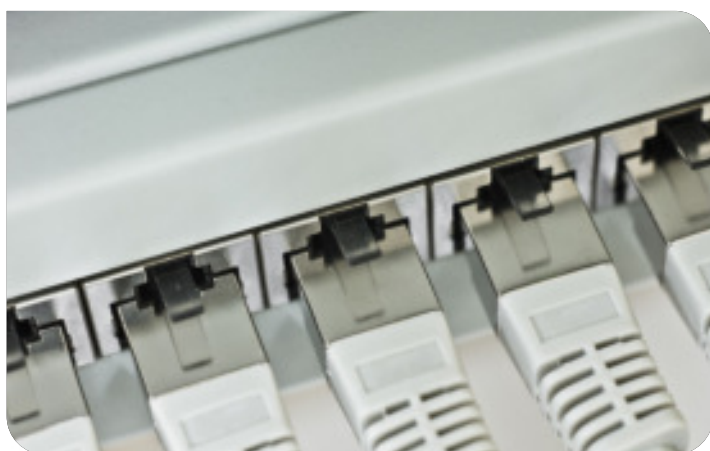
In the measurement method described above, the AEM testers perform further post processing of data to find actual impedance changes along the length of the cable on common mode signals. In addition to improving measurement reliability, this also gives unique ability to identify transition of cabling construction technologies, such as from SSTP to FTP.
